**DEPARTMENT OF TRANSPORTATION****DIVISION OF ENGINEERING SERVICES**

Contract #: 04-0120F4Cty: SF/ALA Rte: 80 PM: 13.2/13.9File #: 1.28**WELDING INSPECTION REPORT****Resident Engineer:**Siegenthaler, Peter**Address:** 333 Burma Road**City:** Oakland, CA 94607**Report No:** WIR-026213**Date Inspected:** 29-Aug-2011**Project Name:** SAS Superstructure**OSM Arrival Time:** 700**Prime Contractor:** American Bridge/Fluor Enterprises, a JV**OSM Departure Time:** 1730**Contractor:** American Bridge/Fluor Enterprises, a JV**Location:** Job Site

## WELDING INSPECTION REPORT

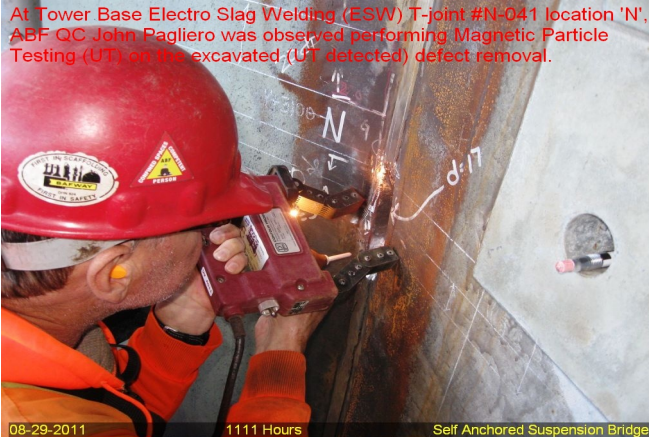
08-29-2011 1111 Hours Self Anchored Suspension Bridge

At Tower Base Electro Slag Welding (ESW) T-joint #N-041 location 'N', ABF QC John Pagliero was observed performing Magnetic Particle Testing (MT) on the excavated (UT detected) defect removal.

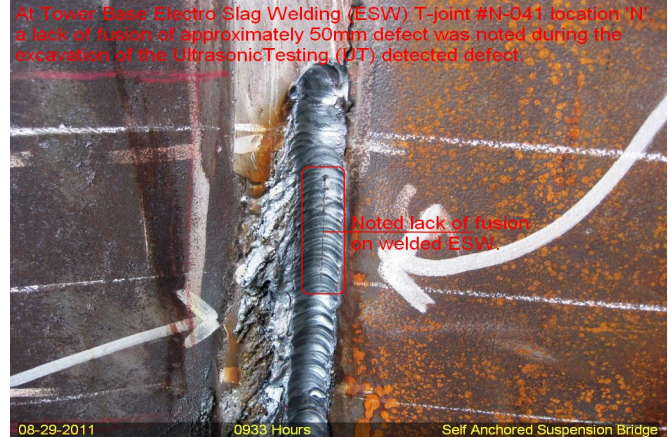
08-29-2011 0933 Hours Self Anchored Suspension Bridge

defect at Y=3020mm was noted with approximately 50mm long of lack of fusion while the other (UT) defect at Y=3220mm was noted with slag inclusions. Both defects were excavated to a boat shape profile with dimensions 200mm long x 45mm wide x 40mm deep and 200mm long x 45mm wide x 28mm deep respectively. After the completion of the excavation, ABF QC John Pagliero performed Magnetic Particle Testing (MT). QC has found the two (2) excavations' defects removal satisfactory. This QA verified the same excavations with similar results.

At Tower Base Electro Slag Welding (ESW) T-joint #N-041 location 'N', a lack of fusion of approximately 50mm defect was noted during the excavation of the Ultrasonic Testing (UT) detected defect.

During the routine visit of Caltrans Engineer Saman Soheili at the site, he noted the excavation at ESW location 'N' was completed and the testing performed by ABF QC and QA satisfactory. He later informed this QA that he is verbally approving the welding repair of the two excavations mentioned above pending submission of the Request for Weld Repair (RWR) by ABF to Caltrans.

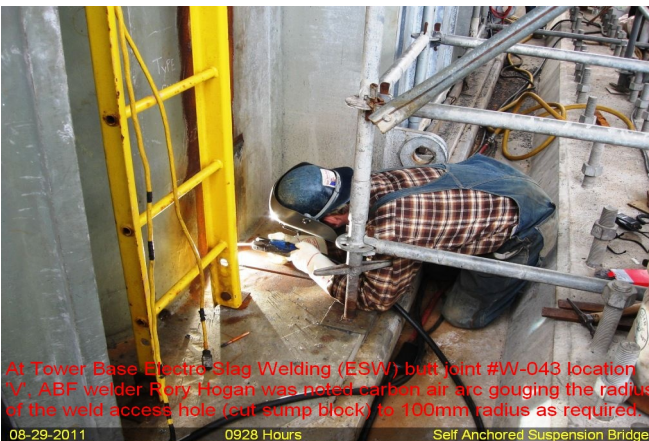
08-29-2011 0928 Hours Self Anchored Suspension Bridge

At ESW locations 'T', 'V' and 'L', ABF welder was noted carbon air arc gouging the bottom weld access hole after the sump block removal. The weld access holes were previously cut using the thermal lance cutting but they were so rough and not cut to 100mm radius as required. The completely gouged weld access holes were also ground smooth by Jeff Souza.

At Tower Base Electro Slag Welding (ESW) butt joint #W-043 location 'V', ABF welder Rory Hogan was noted carbon arc gouging the radius of the weld access hole (cut sump block) to 100mm radius as required.
